Regional Sediment Management (RSM) Assessment of Longboat Pass, Manatee County, FL

by Kelly R. Legault

PURPOSE: This Coastal and Hydraulics Engineering Technical Note (CHETN) describes the history of ebb shoal morphology at Longboat Pass, Manatee County, FL, based on a review of the history and the recent inlet management studies for proposed navigational dredging of the Pass. The study area is located on the southwest Gulf of Mexico coast of Florida (Figure 1). The goals of the study were to determine the best channel configuration for navigation and most appropriate beneficial use of dredged sediments (the primary criteria used to evaluate channel alternatives).

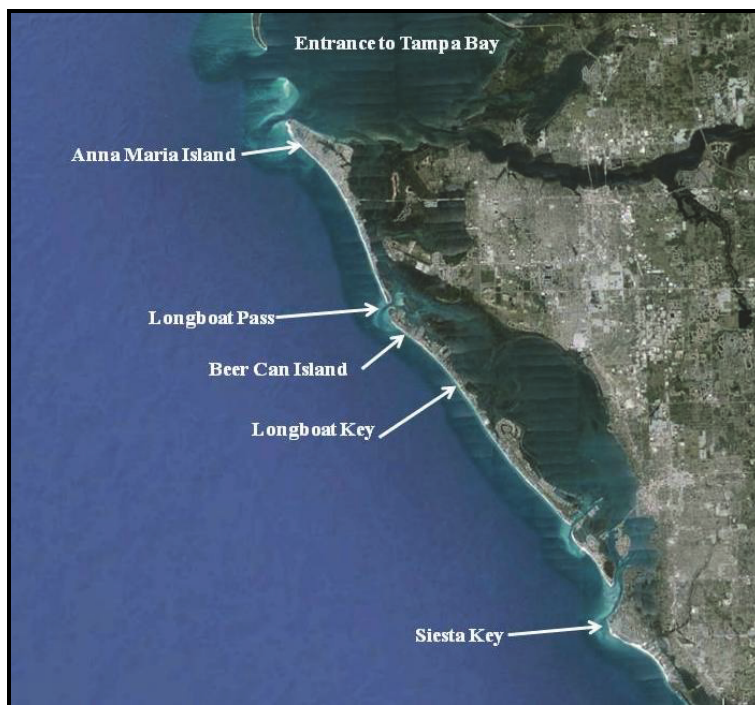
Figure 2. Longboat Pass, FL, and Longboat Key segment of Sarasota County Shore Protection Project (SCSPP-LK).

INTRODUCTION: Longboat Pass (Figure 2) is a Federal navigation inlet authorized in 1975. The navigation inlet was constructed in 1977. There are two Federal shore protection projects near Longboat Pass: (1) Manatee County Shore Protection Project (MCSPP) serving Anna Maria Island to the north and (2) Sarasota County Shore Protection Project–Longboat Key Segment (SCSPP-LK) serving Longboat Key to the south (Figure 2). This CHETN, funded by the U.S. Army Corps of Engineers (USACE), Regional Sediment Management (RSM) Program, is the result of a review by the USACE Jacksonville District (SAJ) of the history of Longboat Pass and the recent inlet management studies for proposed navigational dredging of Longboat Pass in Fiscal Year 2015.

Longboat Key is presently experiencing erosion of the shoreline immediately south of Longboat Pass (Figure 2). The Town Commission of Longboat Key has expressed concern that the erosion on northern Longboat Key is due to the southerly migration of the channel at Longboat Pass and that the erosion may continue if the Federal channel alignment is changed to follow the natural channel (Manatee County 2010). In regard to navigation maintenance of the Pass, Humiston & Moore Engineers (2008) suggested dredging the Federal channel to mimic the present natural alignment as opposed to the previously maintained alignment and placing the dredged sediment on Longboat Key where the erosion is occurring. Coastal Planning & Engineering (2011) suggested dredging the Federal channel following the Authorized Channel configuration, and placing sediment on Longboat Key in conjunction with coastal structures to maintain the beach adjacent to the Pass.

The earliest monitoring of Longboat Pass began with an 1886 hydrographic survey of the area. Both the USACE (1975) and Humiston & Moore Engineers (2008) documents indicate that, prior to development of the area, the inlet-barrier island system was highly dynamic. Changes in inlet location and configuration were common, including alternate inlet openings and closings. Early modification of the inlet began in the 1950s. Prior to Federal participation, local interests dredged the inlet in 1951 and 1959. Additionally, a jetty was constructed on the north side of the inlet in 1957 to support the bridge that connects the barrier island to the north (Anna Maria Island) with the island to the south (Longboat Key). The jetty stabilized the north side of the inlet, but the sand spit south of the inlet known as Beer Can Island continues to evolve (Figure 2).

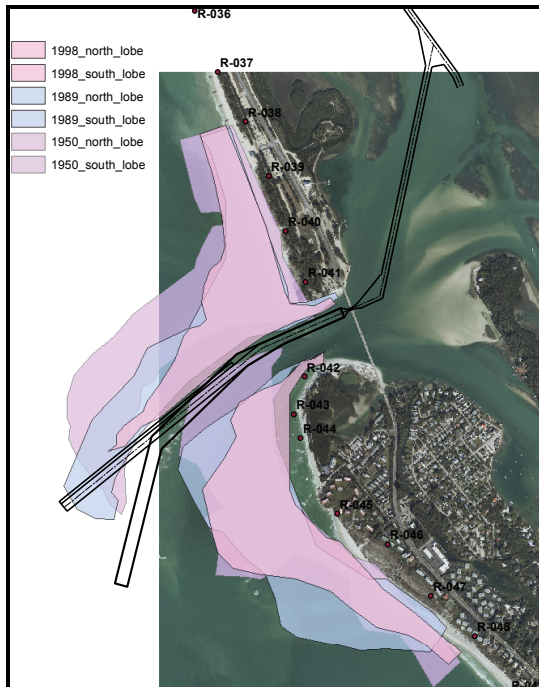
Figure 3. Longboat Pass ebb shoal planform during years 1950, 1989, and 1998. Aerial taken in 2014. Authorized Channel (straight). Alternative channel (dog leg).

Historical and present ebb shoal planform. The 1950 ebb shoal planform had a very large northern lobe before the construction of the jetty at the southern end of Anna Maria Island and the bascule bridge over Longboat Pass in 1957 (Figure 3). The 1989 ebb shoal planform depicted the time period after the initial dredging of the Federal channel in 1977 and after navigation maintenance dredging in 1981 and 1985. The northern lobe of the ebb shoal generally followed the limits of the authorized Federal channel; however, the distal portion of the northern lobe intersected the mouth of the channel. The 1998 ebb shoal configuration depicted the evolution of the ebb shoal after the removal of 2.3 million yd³ of sediment from the shoal in 1993. Figure 4 shows the ebb shoal configuration in 2010 and 2014. The authorized (straight) Federal channel delineation completely bisected the northern lobe of the ebb shoal, and the northern lobe of the shoal was encroaching on the dog-leg alternative channel configuration. The dog-leg alternative channel configuration was evaluated because it more closely followed best navigable water in 2010.
